# The Incorporation of Pitting Corrosion Damage into F-111 Fatigue Life Modelling

T. Mills, P. K. Sharp and C.Loader
DSTO-RR-0237

DSTO-RR-0237

AR-012-354 June 2002

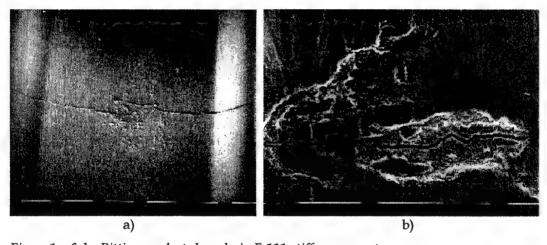
As part of the CPLT process, many pre-test inspection programs have been implemented over the years. These inspections are designed scrutinise problem areas before the CPLT is conducted to prevent failures during the test. These inspections have averted costly failures and highlighted new problems. For instance, cracks were found in the No. 2 stiffener runout in the upper WPF of two Australian F-111Cs (A8-148 and A8-109) [Cox 1985]. In both cases, the cracks initiated from corrosion pits and the initial fracture was intergranular before developing into a more typical striated fatigue crack. However, the extent of the intergranular fracture was only one grain deep and did not contribute significantly to the overall crack length. The intergranular crack growth probably occurred by a stress corrosion cracking (SCC) mechanism. The fracture in A8-109 started from three separate pits, and the cracks initially grew at approximately the same rate before joining to form one large crack. Pit/crack interaction is shown in Figure 1 a & b.

Figure 1 a & b. Pitting-nucleated cracks in F-111 stiffener runout.

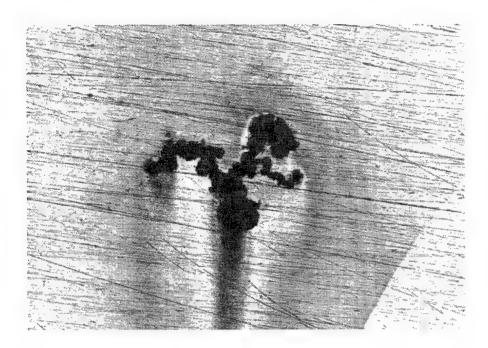
The low growth rates of the corrosion produced a very strong and cohesive corrosion product that provided a site for self-propagating filiform corrosion. This developed where the corrosion product provided an interface under which an active site could react to produce more corrosion product. This extended the interface and moved the active site with time and resulted in wormlike trails of corrosion extending across the surface of the specimen (Figure 6).

Figure 6. 'Wormlike' self-propagating filiform corrosion on the surface of D6ac steel.

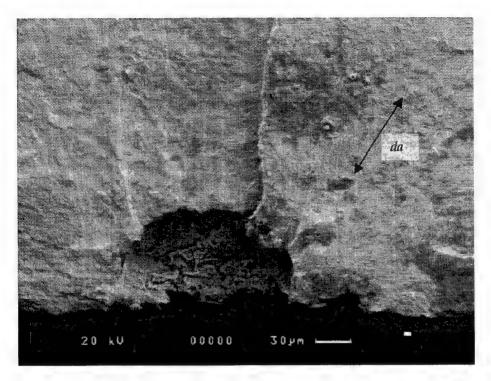
Figure 16. Marker bands on the fatigue surface of a pitted D6ac specimen.

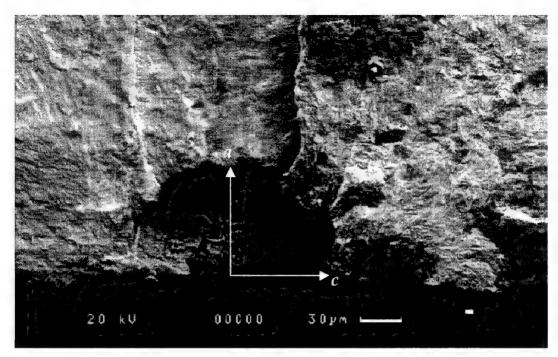
Figure 26. Nearly perfect hemispherical pit with aspect ratio, a/c = 1.

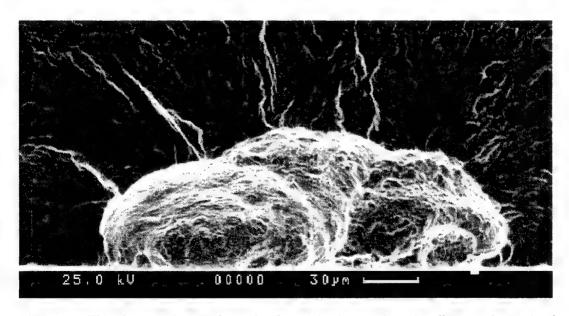
Figure 27. This shows a cluster of pits that have joined to produce, in effect, one large pit of very low aspect ratio, in this case a/c = 0.69.

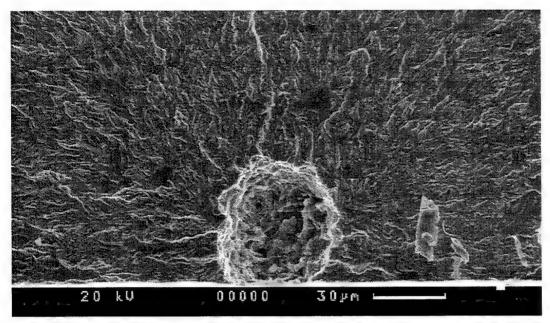
Figure 28. Some of the pits seem to have grown as a complete sphere under the surface, which gives rise to a high aspect ratio, in this case a/c = 2.23.

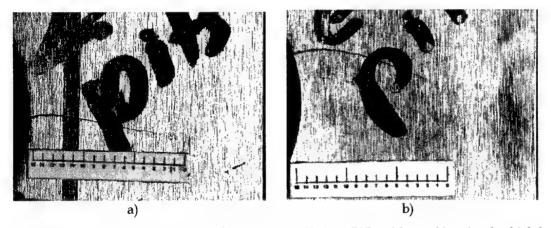
Figure 42. Crack camera image of a) specimen EM47AF2B with cracking in the high- $k_t$  location, and b) specimen EM49AA2B with cracking much higher up the radius of the cut-out.

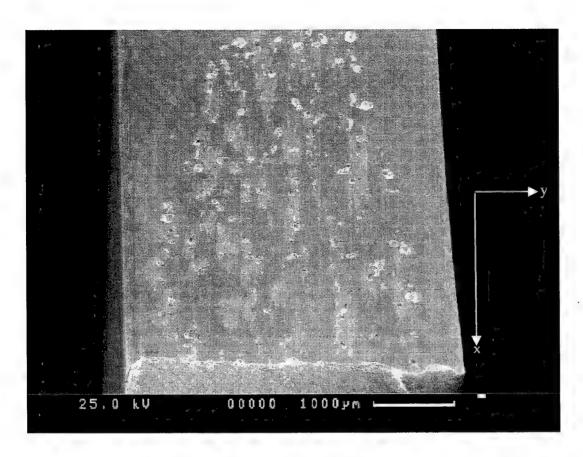
Figure 47. Pitting corrosion on radius of oval hole coupon. Fracture plane was in high stress location.

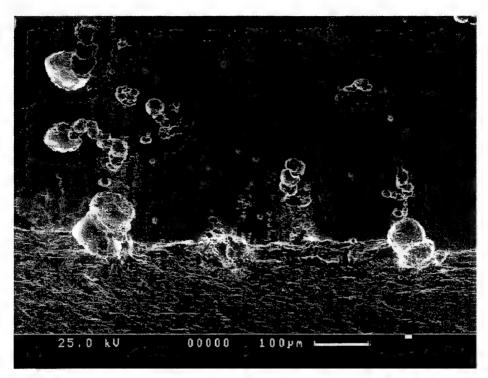
Figure 48. Collection of pits on specimen radius intersecting with fatigue fracture surface.

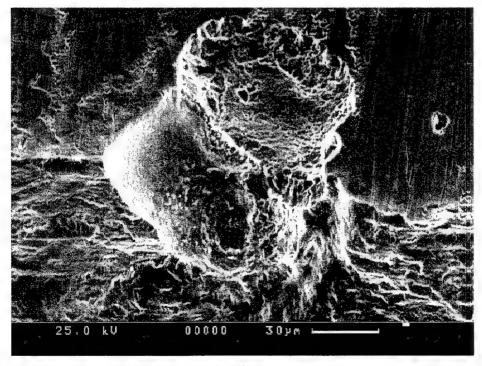
Figure 49. Higher magnification view of pit/fatigue interaction.

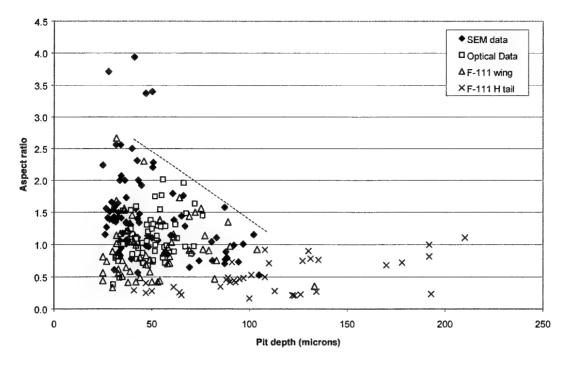
Virtually every pit that had very high aspect ratios (a/c > 2) were found in the SEM. These pits tended to have a very small surface opening. The optical microscope could not see into similar pits well enough to get an accurate depth measurement, so they were not analysed. The optical microscope was much better at measuring pits with a/c < 2. This can be seen clearly in Figure E1.

The pitting damage determined from the wing and pylon fitting matched very well with the laboratory grown corrosion (Figure E1). Again, pits with very high aspect ratios (a/c > 2) were rare, a couple of exceptions being found in the micrographs from the pylon fitting. The replica techniques used on the rest of the pits probably would not be able to not resolve this type of morphology.

Figure E1. Pit depth vs. aspect ratio for laboratory and in-service corrosion.

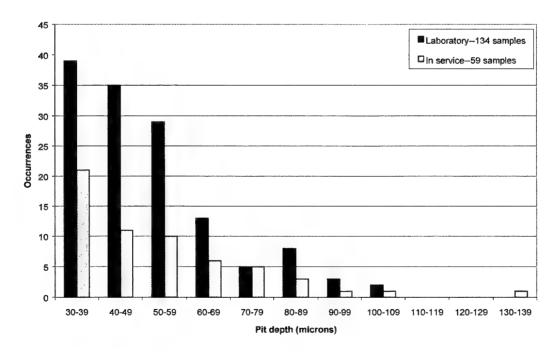
Figure E2. Pit depth histogram for laboratory vs. in-service pitting.

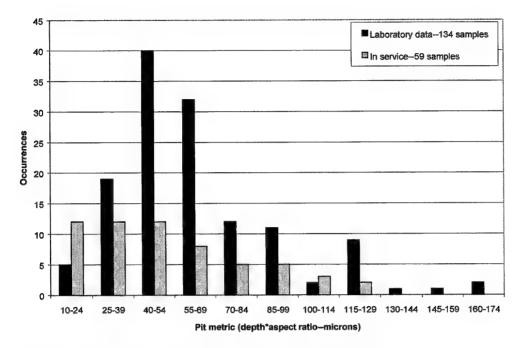
laboratory (discussed earlier). This is not cause for great concern, as the pit metric (depth \* aspect ratio) used to determine ECS covers a greater range in the laboratory damage than the in-service damage. This is shown in Figure E3.

Figure E3. Pit metric histogram for laboratory vs. in-service pitting.
